# Northampton Street

## Artspace Buffalo

### Parcel Inventory

### Observations, Conditions, Opportunities

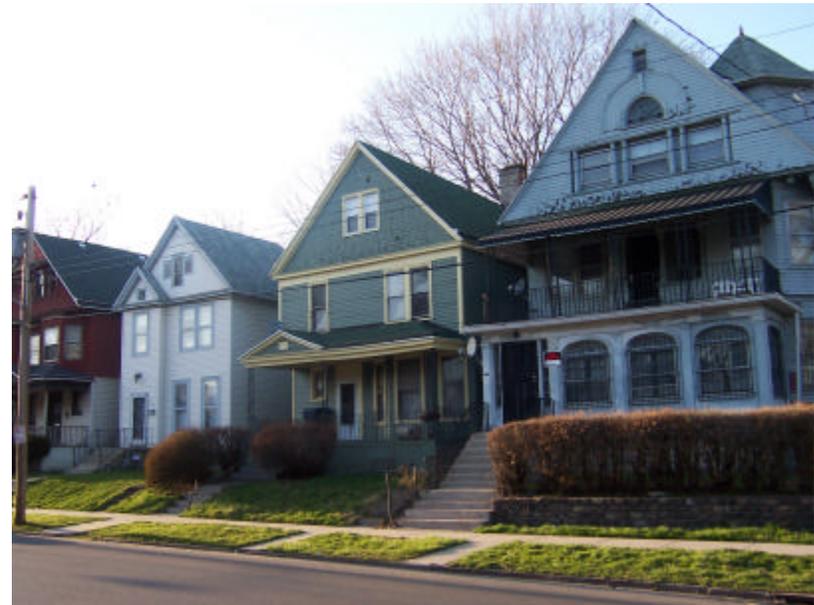
*Northampton Street contains Midtown's most opulent homes.*

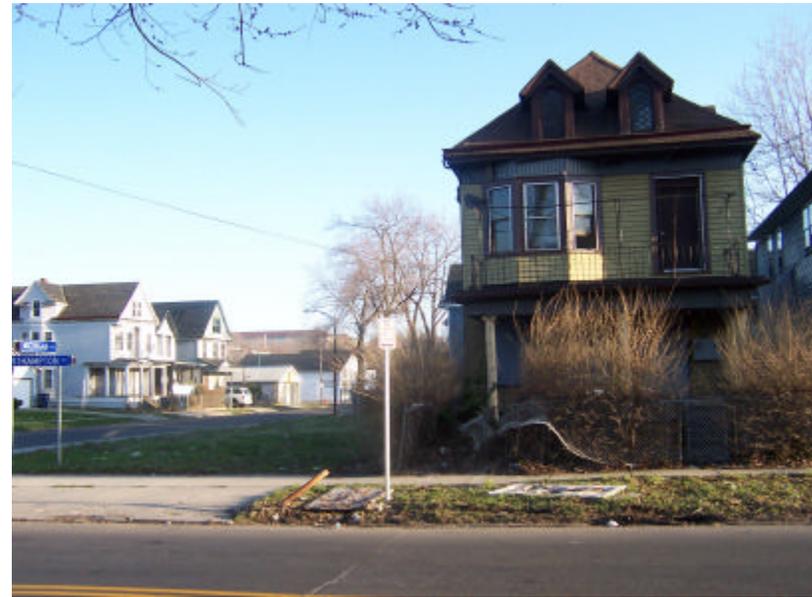
As soon as Northampton crosses east of Holland Place, the integrity of the original housing declines rapidly. In what should be a showcase of a stabilized East Side neighborhood strengthened by its unique character, Northampton ebbs in the stretches beyond the focus of its largest and most elaborately detailed homes. Houses like 91 and 94 Northampton sit abandoned, awaiting rescue. Vacant lots have already begun their intrusion onto the street, although in most instances have been revived as well-maintained gardens and side yards. In one

*The houses of Northampton, closer to Michigan Avenue, remain at risk of demolition or further degradation. They are important to save.*

particular instance, it's obvious that several homes were demolished to make way for a "plain Jane" suburban-style home on a nearly half-acre lot at 61 Northampton, right in the mix on the corner with Ellicott, intruding upon an architecturally sensitive environment. It will be crucial to stabilize at-risk properties on the block to prevent its further degradation or replacement by ahistoric development.

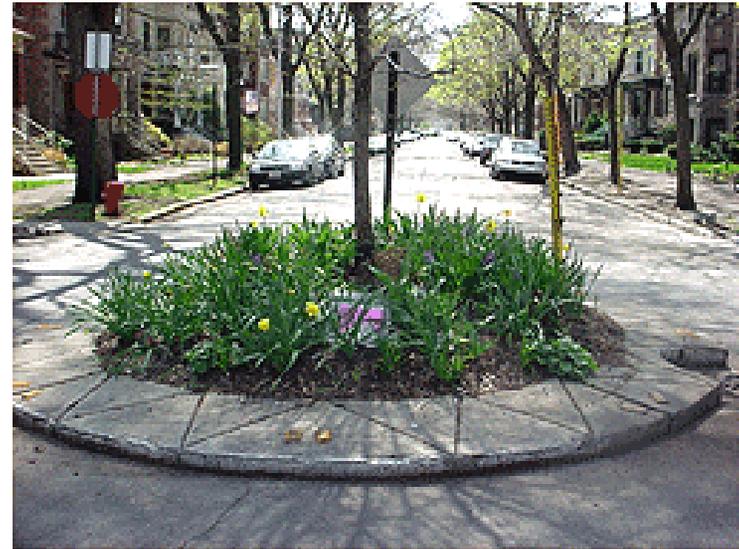
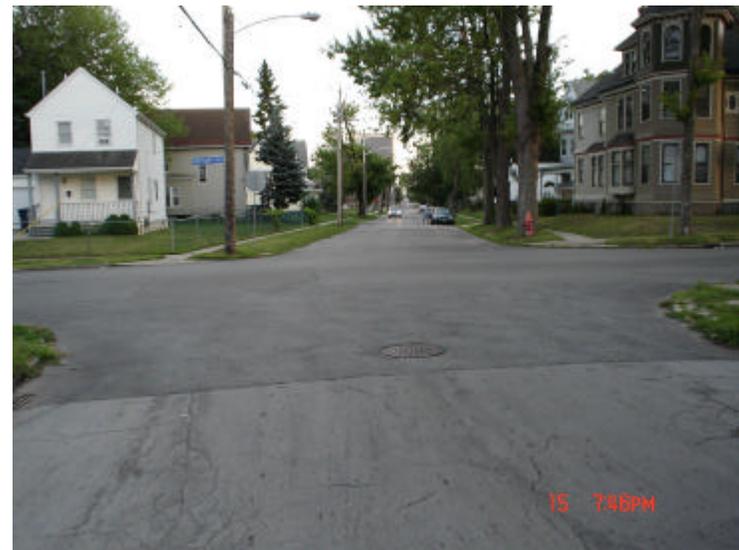
The intersection of Northampton and Ellicott streets is really a center of gravity for Midtown. It is a terminating vista for Ellicott Street that could be enhanced by:

*It's easy to foresee a mini-traffic circle being installed at this intersection.*

#### *Install mini-traffic circle at the corner of Northampton and Ellicott streets*

- The installation of a landscaped traffic circle, the corner could act as a centering device for the block. It would also calm traffic at an intersection where very few drivers come to a full stop anyway. In what would be the first traffic circle to be installed in the city in recent memory, it would beautify the area and set it apart.
